Flagler County Emergency Services

147.300 Repeater Diagnostics

Date: 20-May-2010

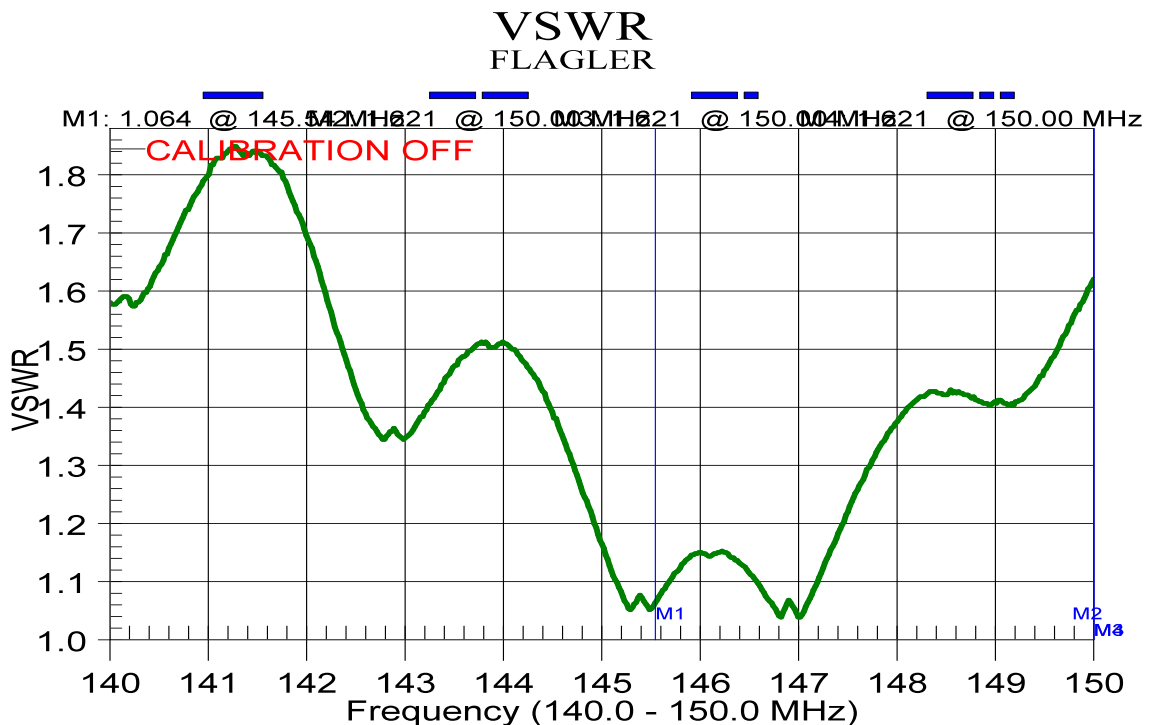
No anomalous results were observed. The antenna and feed line were found to be in good condition, with the following additional observations:

- Measured VSWR at the repeater operating frequency of 147.300 was 1:1.15, with marginally higher VSWR on the receiver input frequency of 147.900 of 1:1.39. Both values were within limits for use in the amateur band.
- Overall resonance of the antenna was well within the 144-148mhz Amateur Band with no VSWR exceeding 1:1.5.
- Usable range of the antenna was from 142.500 to 150.000 mhz with VSWR of less than 1:1.6

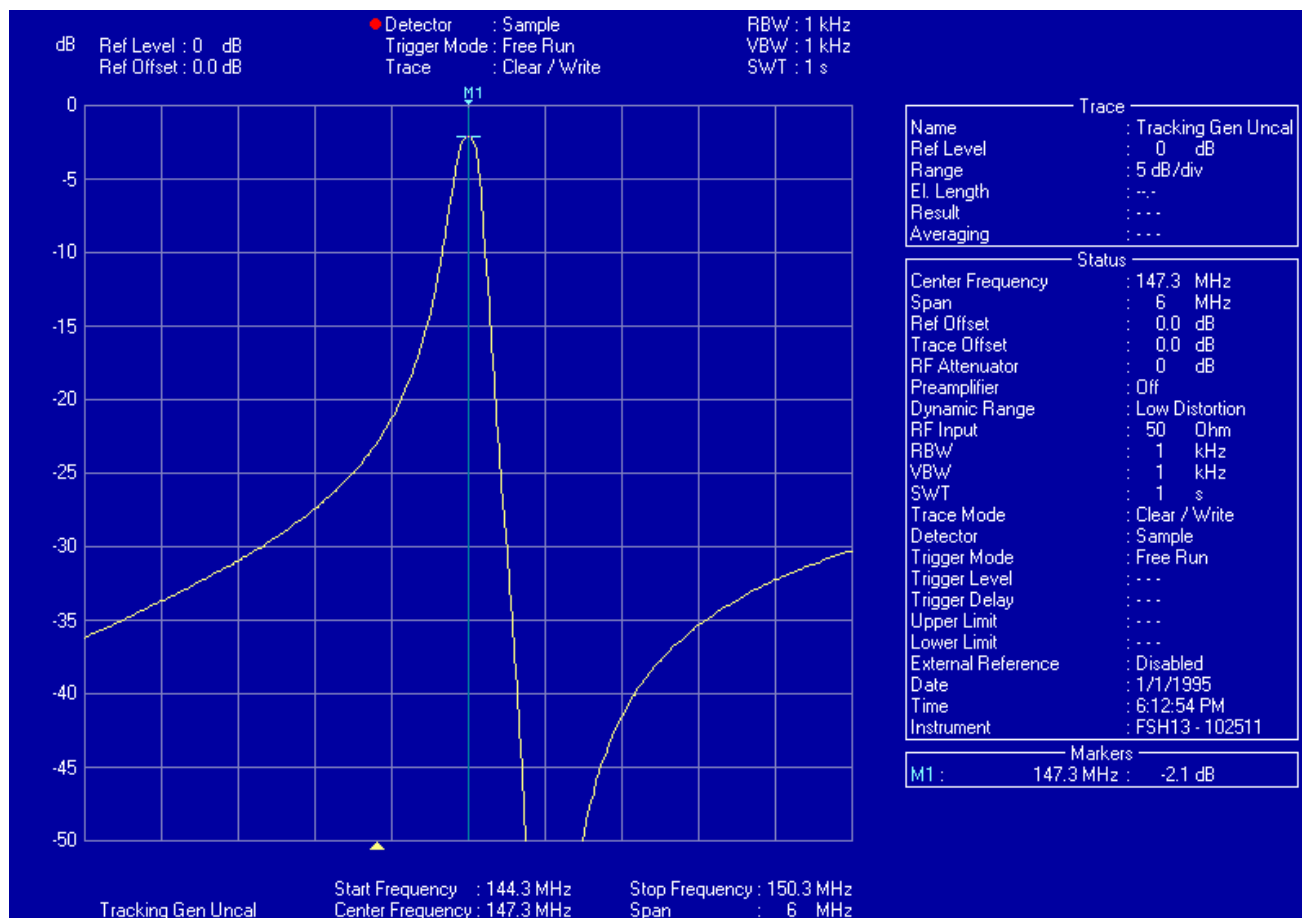
Transmit PASS at 147.300mhz , Insertion Loss of 2.1db,
Reject notch +600khz at 147.900mhz

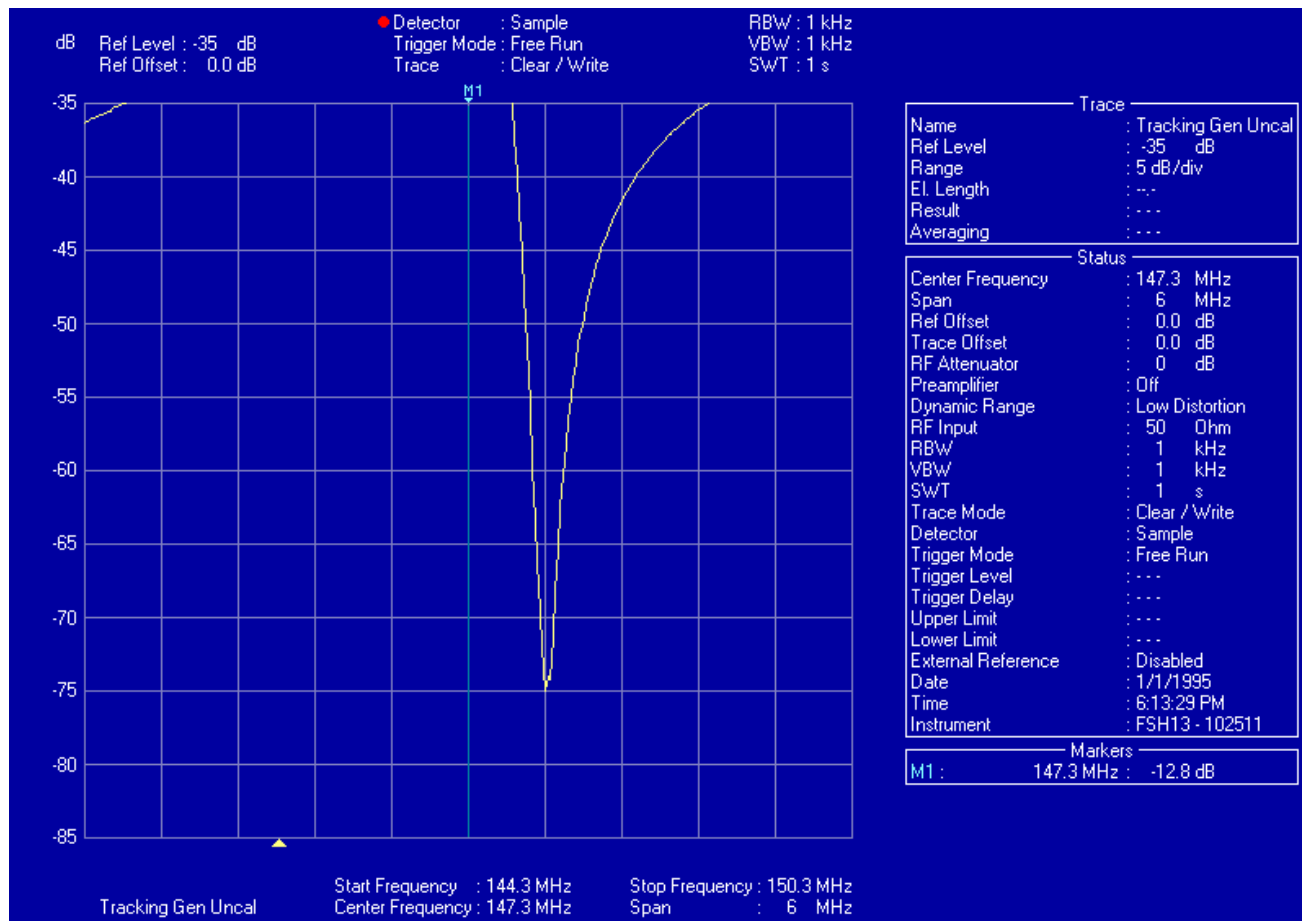
Reject NOTCH at 147.900mhz (Receiver side), overall performance of 128db

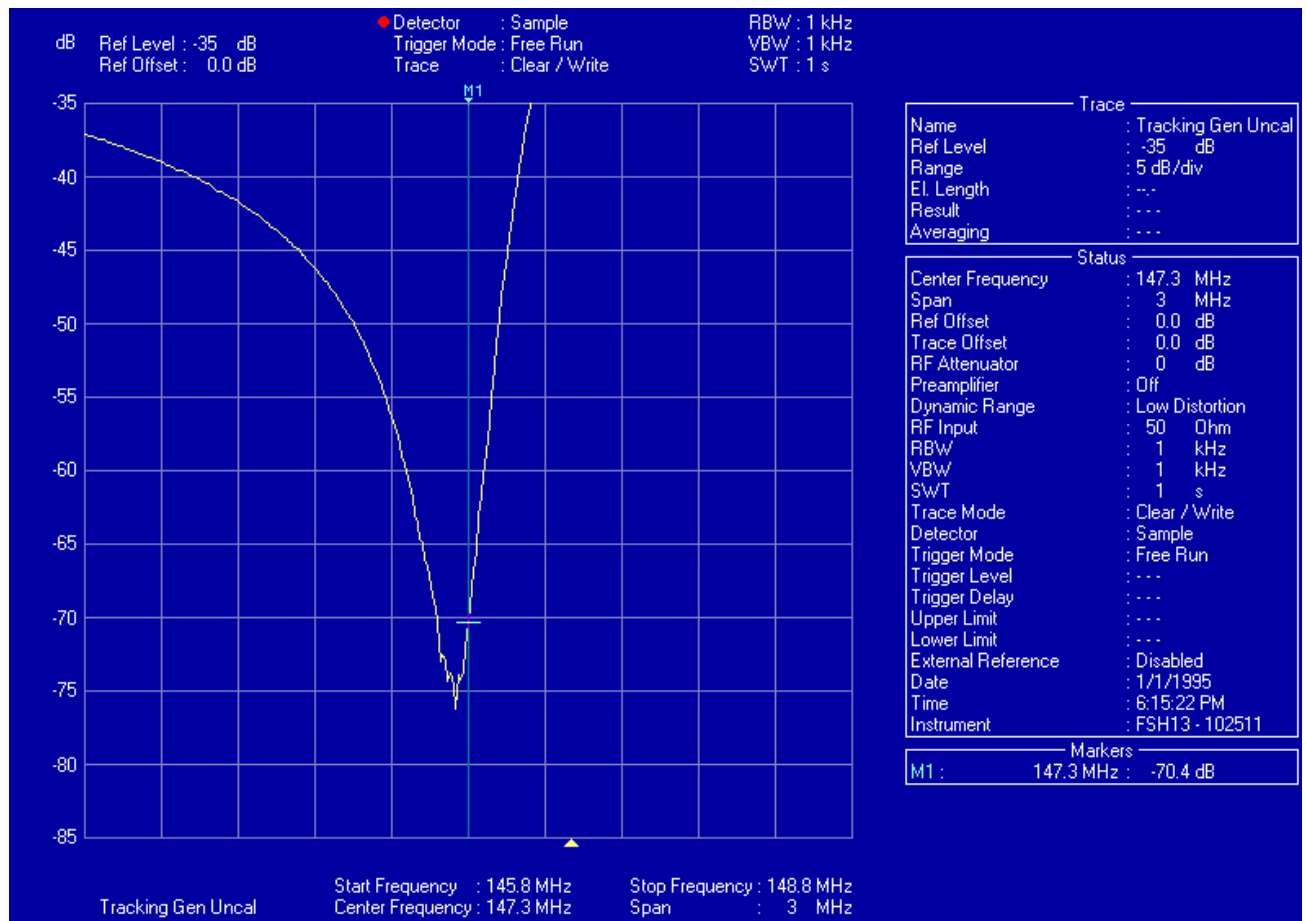
- The Wacom 4-cavity VHF duplexer was found to be **slightly off frequency** on both the LOW and HIGH sides when measuring Pass-Band.
- Notch frequencies on both sides of the duplexer were within acceptable limits. The details of the test results
- Sinclair Isolator was found to be ineffective (not tuned properly) in reducing adjacent signal into the receiver.

Old Reject NOTCH – off frequency at 147.270mhz (5db performance loss)

- Return Loss measurements were made on both LOW and HIGH side of the duplexer. All RL was below 24db, but was slightly off frequency (100khz).
- Frequency adjustment was made to center the maximum RL to the LOW and HIGH frequencies respectively.

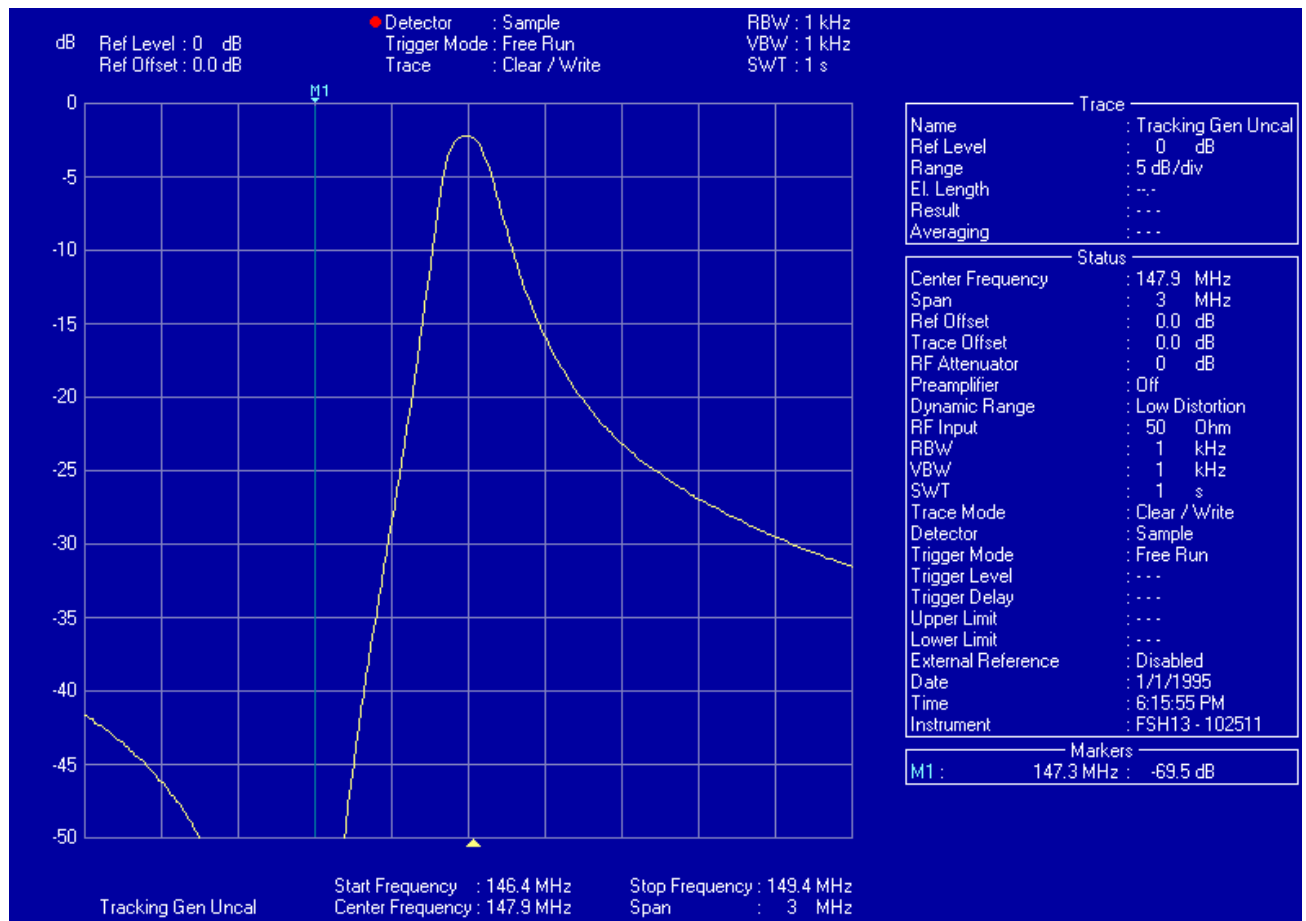
Receiver PASS Performance – 147.900mhz, insertion loss of 2.1db
 Transmit notch at 147.300mhz, reject performance of 69.5db

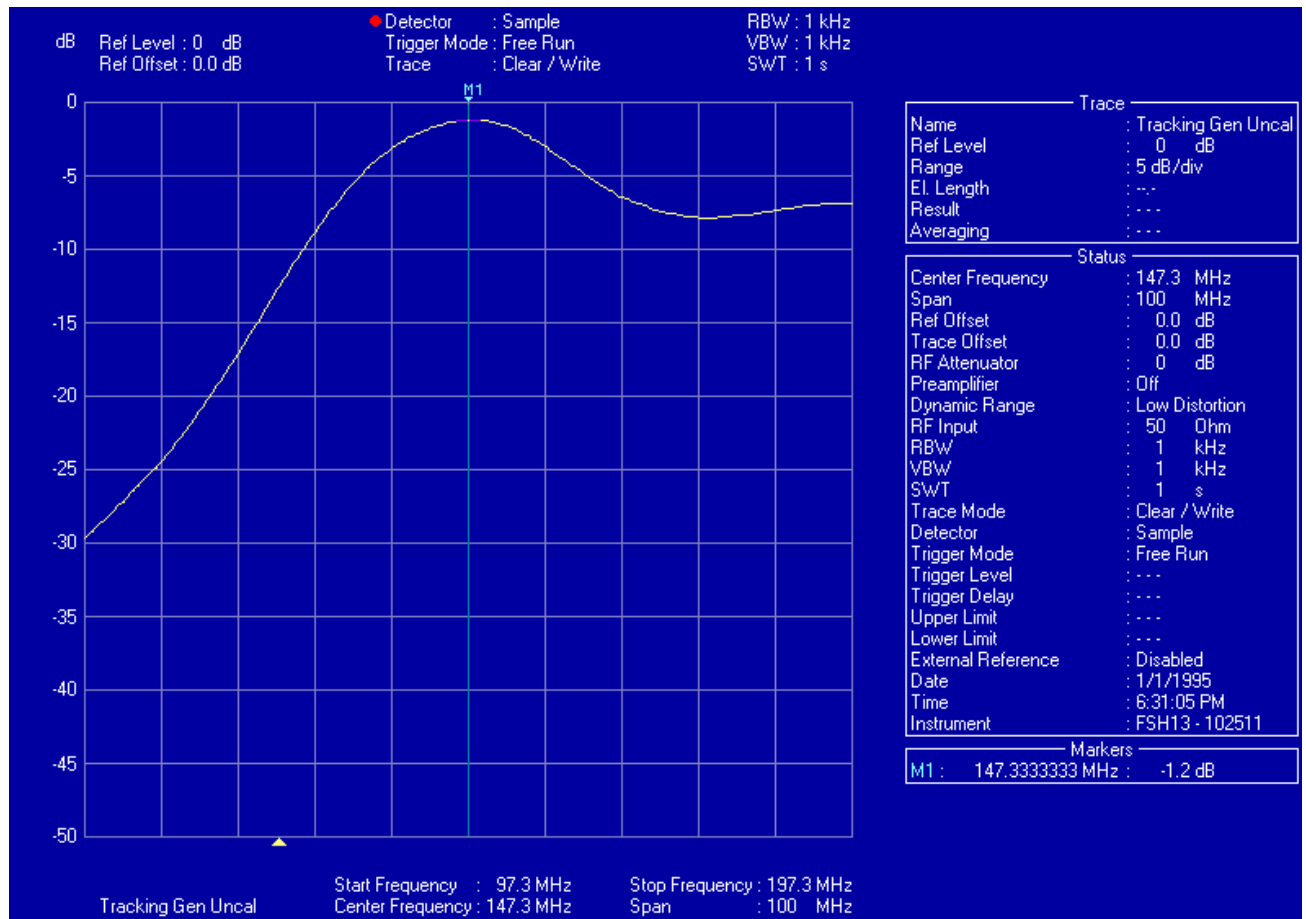
Pass Characteristics of Sinclair Ferrite Isolator

At 147.300mhz (Transmit Fx), provides only 1.2db of insertion loss – roll-off below transmit frequency of -17db at 30mhz BELOW Transmit (Taken offline, since it provides NO additional isolation)

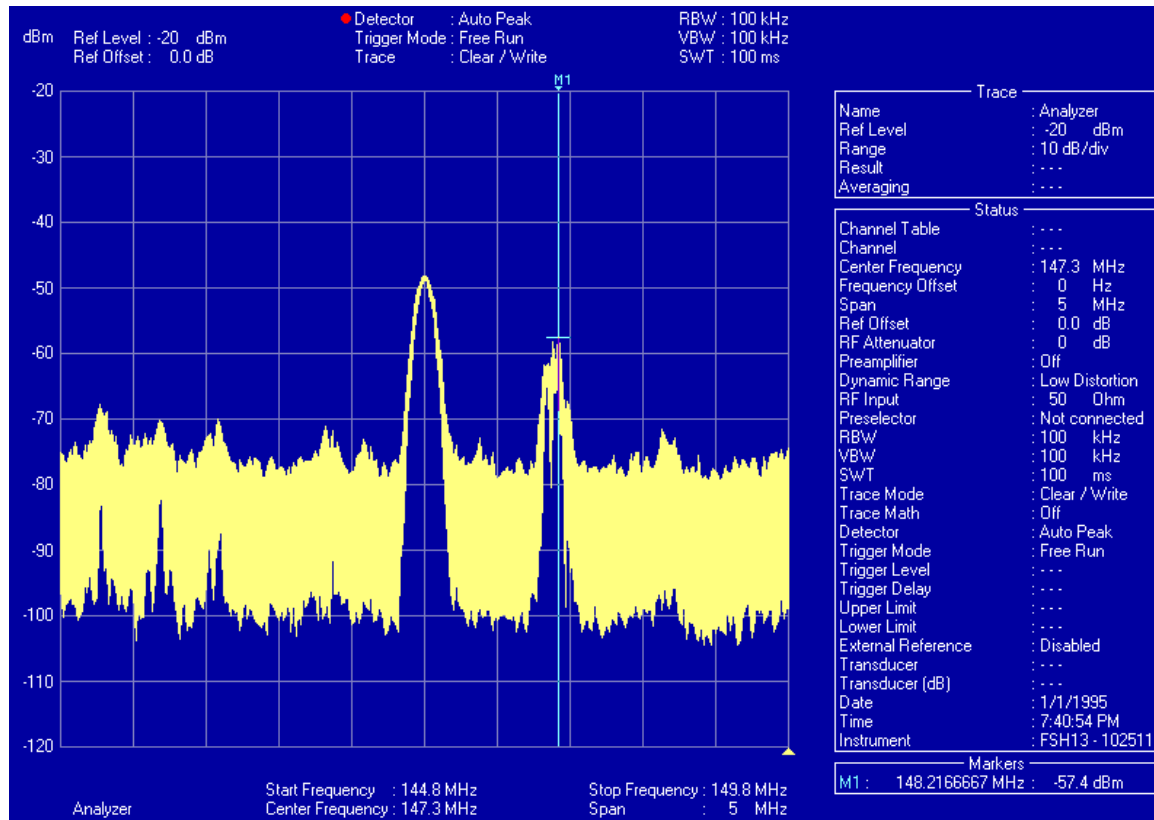
Test #1 – Near Channel Sweep with Spectrum Analyzer

A strong signal adjacent to the Amateur Band at approximately 148.22 was observed inside the room where the repeater is currently housed. Source of the signal is currently unknown, but it is possible that it is a signal-mix or intermodulation from various sources in the room. More research is required in order to isolate the source and to find a cure.

Undetermined as to whether the adjacent signal was present PRIOR to the VXR-9000 being powered-on. Need to test in the near future (see Action Items).

- Perform a Spectrum Sweep of the room, while the repeater is POWERED-OFF
 - If the adjacent frequency is still observed, then we know that there is a signal source from within the room (or outside) that is causing intermod or interference. Try Intermod Filter or Frequency Change (Below)

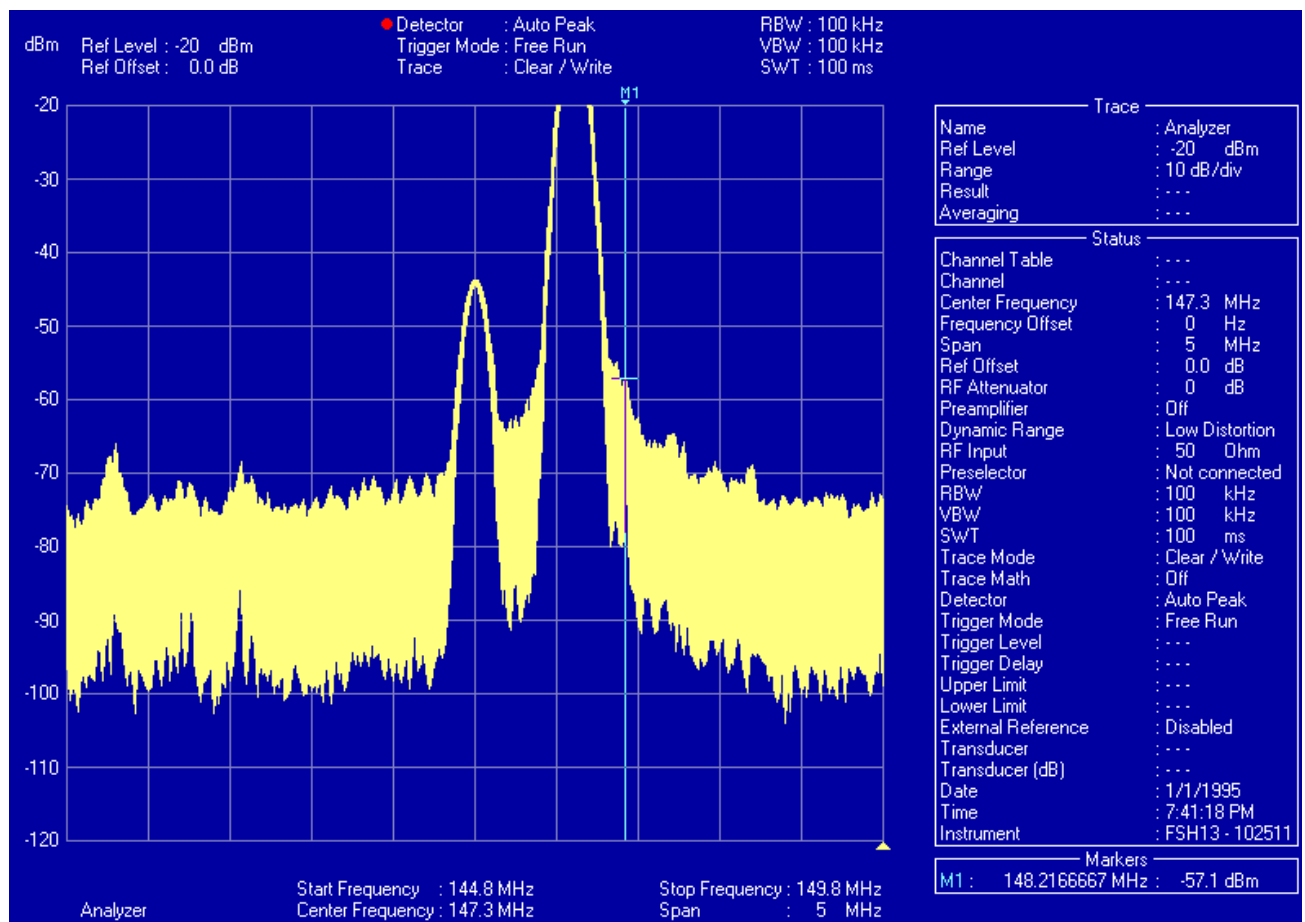
Test #2 – Intermod Sweep with Spectrum analyzer

The transmit signal is shown here at the middle (Vertical) line at a level of approximately -43dbm (over-the-air measurement). Adjacent (almost at the receiver input frequency) is a signal which is over -10dbm, or approximately 33dbm STRONGER than the repeater output (from within the room). This can only be possible if the signal is a mix with other signals within the radio room (VHF pager, other VHF signal, etc.). More research is necessary to isolate and cure the problem.

- Add an Intermod Filter to the Repeater Receiver
 - Add a DCI Systems Filter (Model 146-4H) which will eliminate any out-of-band signals above 148mhz. This may not be sufficient to kill the signal at 148.22, since the skirts of the filter are only about 6db down at 149.000mhz.

- If none of the above appears to resolve the problem, we may need to request a frequency change to a frequency which does not cause harmful mixing products to the receiver input
